Manhole Inspection Summary

Manhole # S33MM_038MH

Insp Date: **11/29/06 12:56 PM**

Location Address: **2101 CHARLES ST**

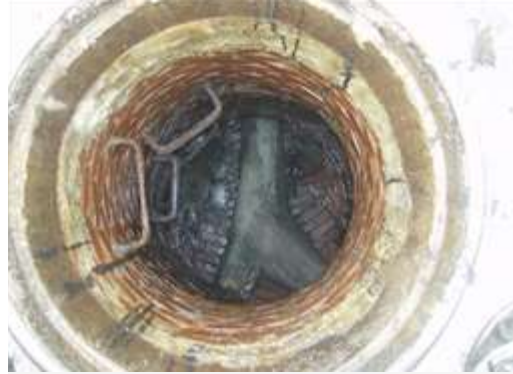
Top View

Corroded steps. Bench debris.

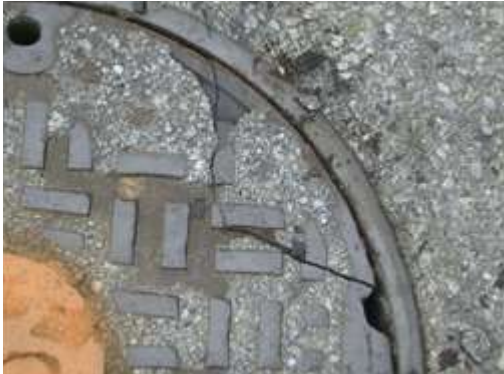
Defect

Condition: **Cracked**

Cracked lid.

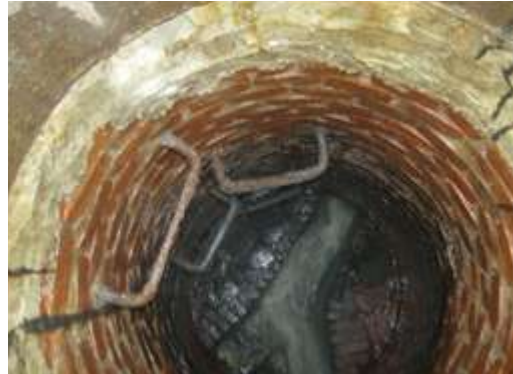
Defect

☒ **Leaks**

Infiltration: ☐ None ☒ **Joint** ☐ Cracks ☐ Mortar ☐ Roots ☒ **Wall**

Infiltration: ☐ None ☐ Joint ☐ Cracks ☐ Mortar ☐ Roots ☒ **Wall**

Frame leaks. Adjustment and Barrel infiltration.

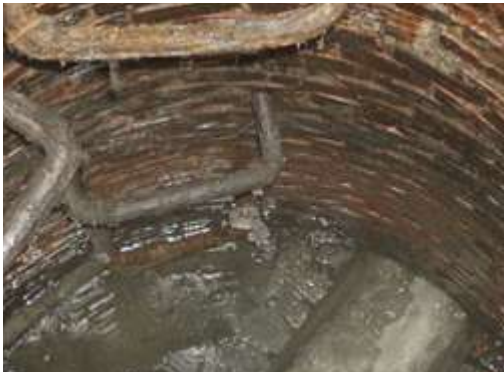
Defect

☒ **Corroded**

☒ **Evidence Of Surcharge**

Barrel infiltration. Corroded steps.
Evidence of surcharge - Bench debris.

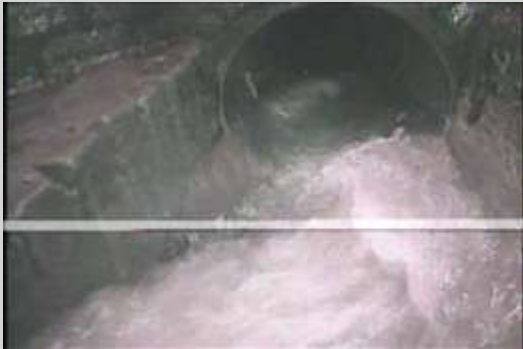
10 in. Circular Gravity Sewer Pipe Out @ 12 O'Clock

Pipe Material: **Clay** ☐ Pipe Lined

Invert Depth: **10.97** (ft.) Flow Characteristics: **Slow**

Deposits: ☒ None ☐ Mud ☐ Sludge ☐ Debris ☐ Grease

Infiltration: **None** Pipe Seal Cond: **Unknown**

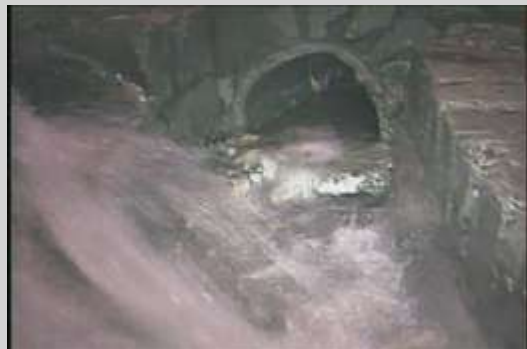
8 in. Circular Gravity Sewer

Invert Depth: **10.95** (ft.) Flow Characteristics: **None**

Deposits: ☐ None ☐ Mud ☐ Sludge ☒ **Debris** ☒ **Grease**

Silt Depth: **2** (in.)

Deposits Extent: **Light**
